# Manhole Inspection Summary

Manhole # S11EE2028MH

**Location** Address: **2311 CROSS COUNTRY BLVD**

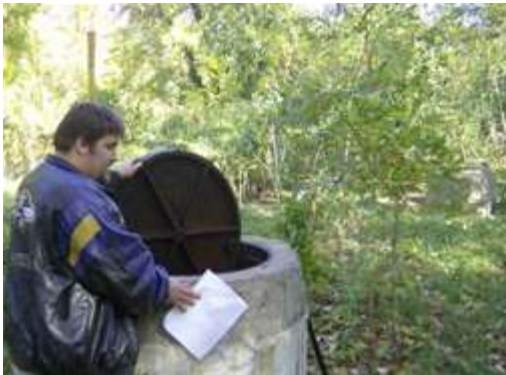
Location View

3 ft above ground

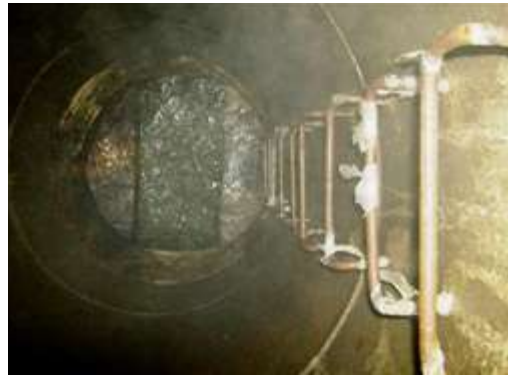
Top View

Adjustment and Barrel infiltration.  
Evidence of surcharge - Bench debris.

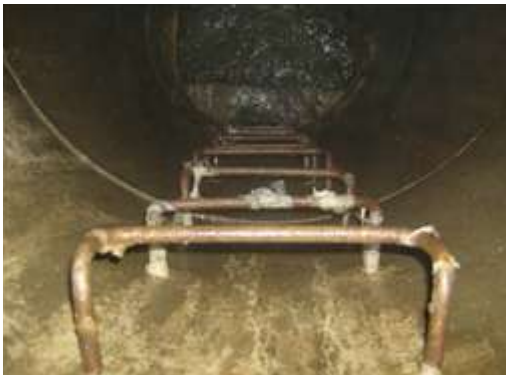
Defect

Adjustment infiltration.

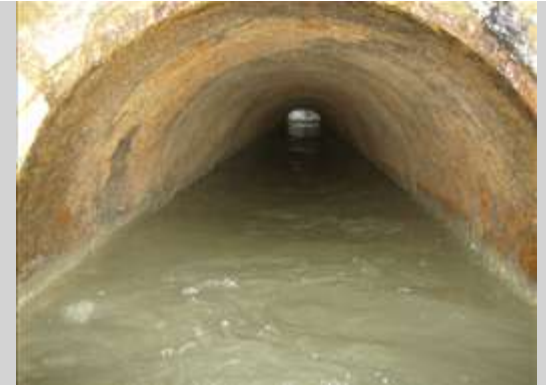
### 27 in. Circular Gravity Sewer Pipe Out @ 12 O'Clock

Infiltration: **Evidence** Pipe Seal Cond: **Unknown**
